# Yocom-McColl Testing Laboratories, Inc.

## Sirolan Laserscan Micron Test Report

Test No: 377211

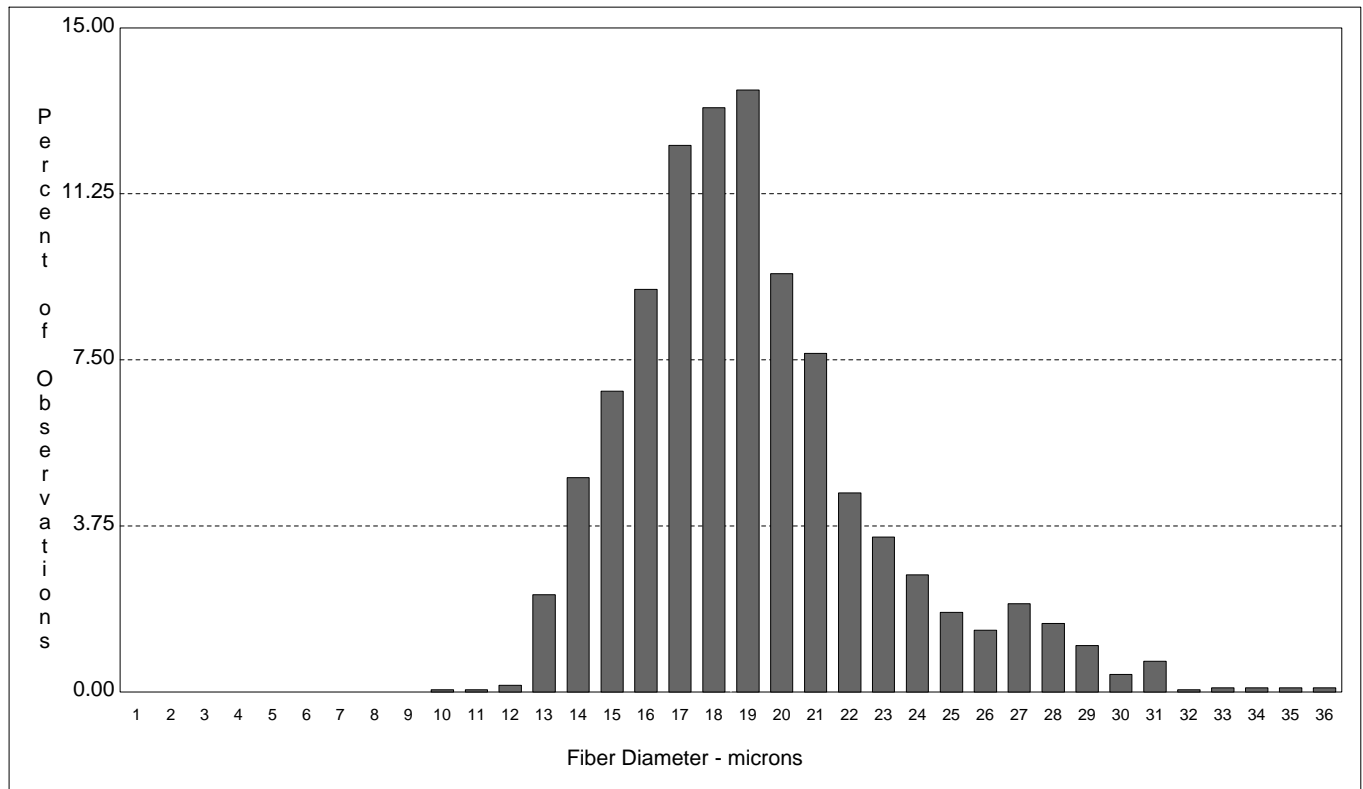
**Mean Fiber Diameter:** 19.3 microns  
**Standard Deviation:** 4.4 microns  
**Coefficient of Variation:** 23.0 %  
**Fibers Greater Than 30 microns:** 1.7 %
