# Yocom-McColl Testing Laboratories, Inc.

## Sirolan Laserscan Micron Test Report

Test No: 943685

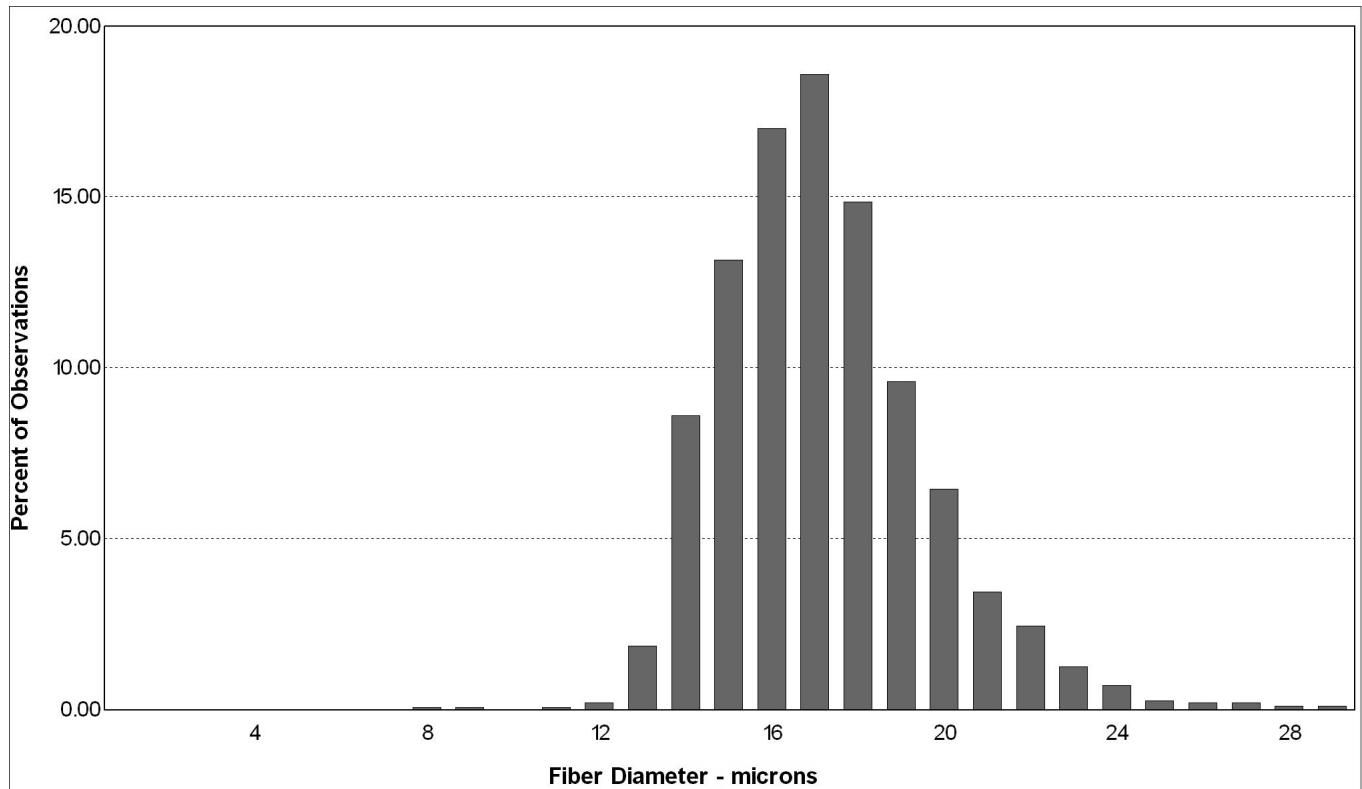
**Mean Fiber Diameter:** 17.4 microns  
**Standard Deviation:** 3.0 microns  
**Coefficient of Variation:** 17.5 %  
**Fibers Greater Than 30 microns:** 0.8 %

This Test Performed According to I.W.T.O Method 12
