## Sirolan Laserscan Micron Test Report

Test No: 978591

**Animal Name:** Durango  
**Breed:** Alpaca(Suri)  
**Sex:** Male  
**Color:** MRG

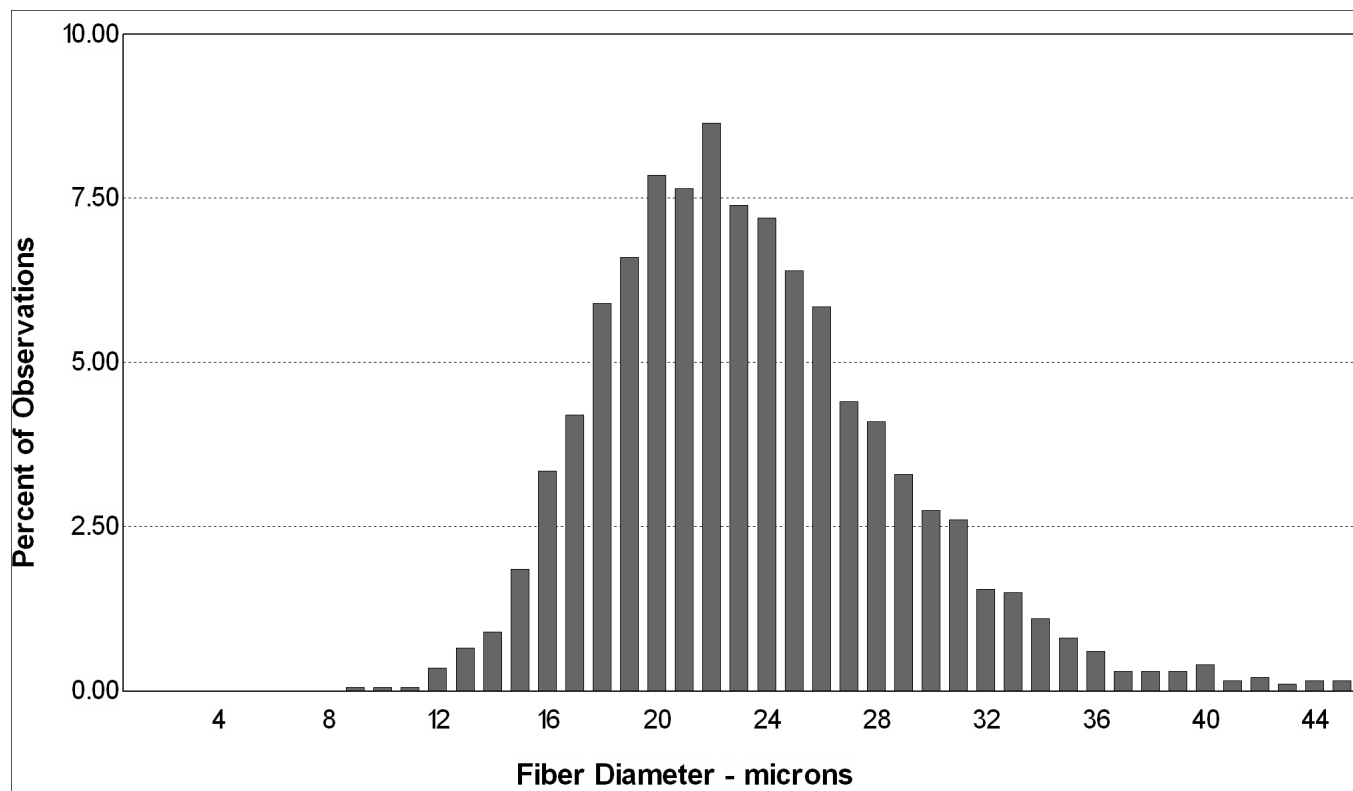
**Mean Fiber Diameter:** 23.5 microns  
**Standard Deviation:** 5.6 microns  
**Coefficient of Variation:** 23.7 %  
**Fibers Greater Than 30 microns:** 10.5 %

This Test Performed According to I.W.T.O Method 12
