### Sirolan Laserscan Micron Test Report

Test No: 391090

#### Animal and Sample Description

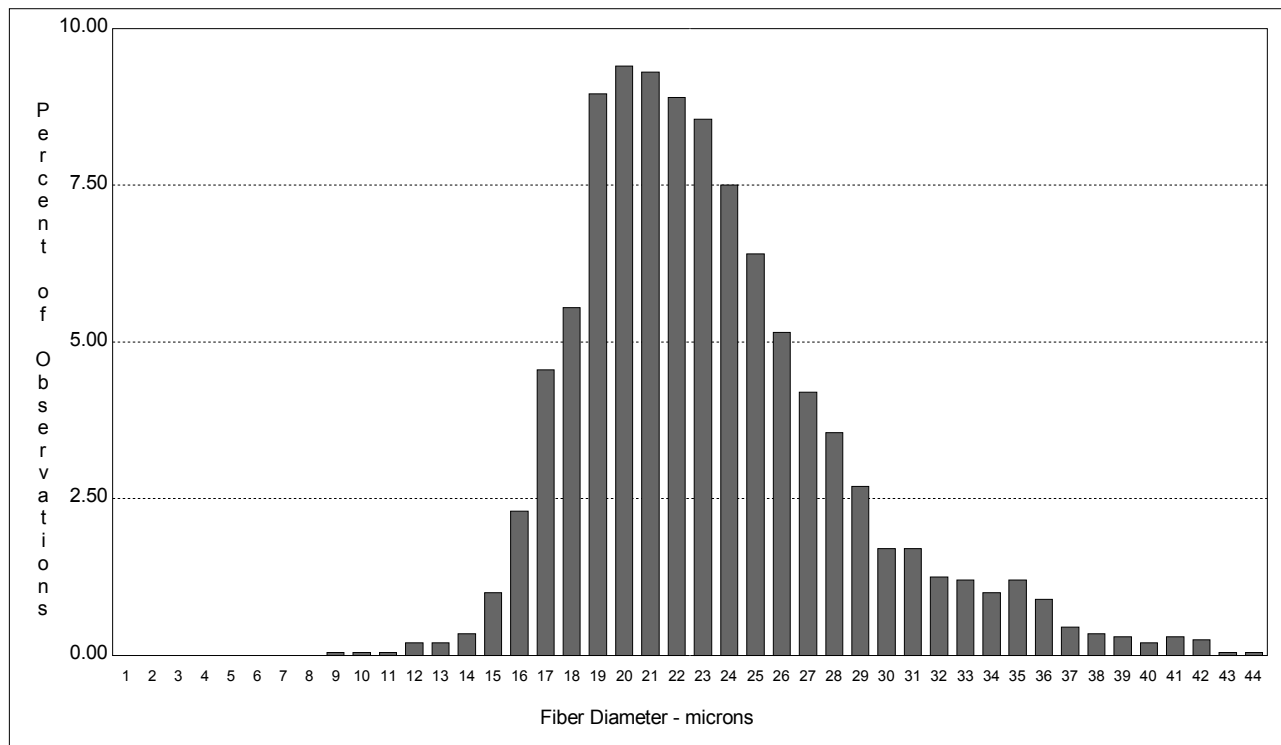
**Mean Fiber Diameter:** 23.3 microns  
**Standard Deviation:** 5.2 microns  
**Coefficient of Variation:** 22.3 %  
**Fibers Greater Than 30 microns:** 9.4 %

This Test Performed According to I.W.T.O Method 12
