## Sirolan Laserscan Micron Test Report

Test No: 941104

**Animal Name:** Crane Creek's Peruvian Peg  
**Breed:** Alpaca(Huacaya)  
**Sex:** Female  
**Color:** Beige

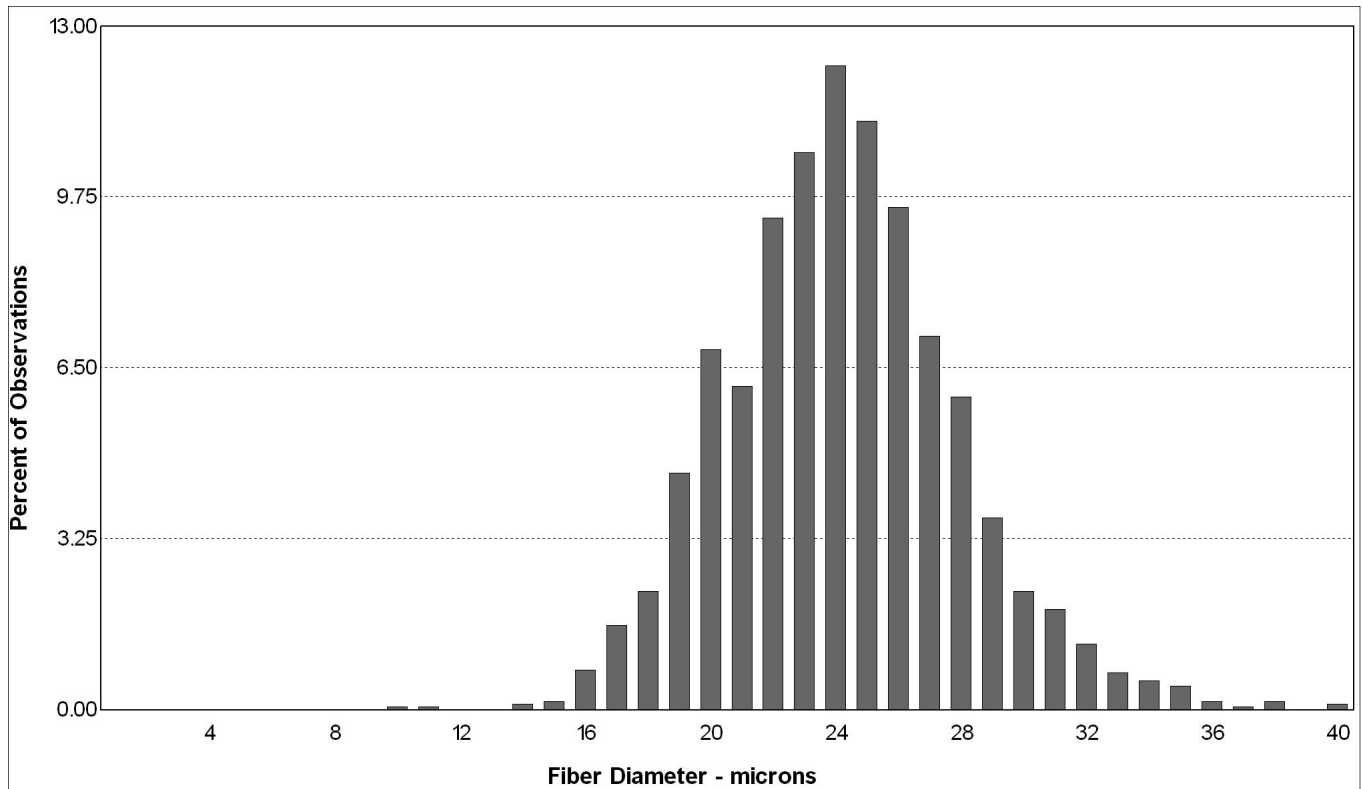
**Mean Fiber Diameter:** 24.3 microns  
**Standard Deviation:** 4.0 microns  
**Coefficient of Variation:** 16.4 %  
**Fibers Greater Than 30 microns:** 5.7 %

This Test Performed According to I.W.T.O Method 12
