# Yocom-McColl Testing Laboratories, Inc.

## Sirolan Laserscan Micron Test Report

Test No: 925614

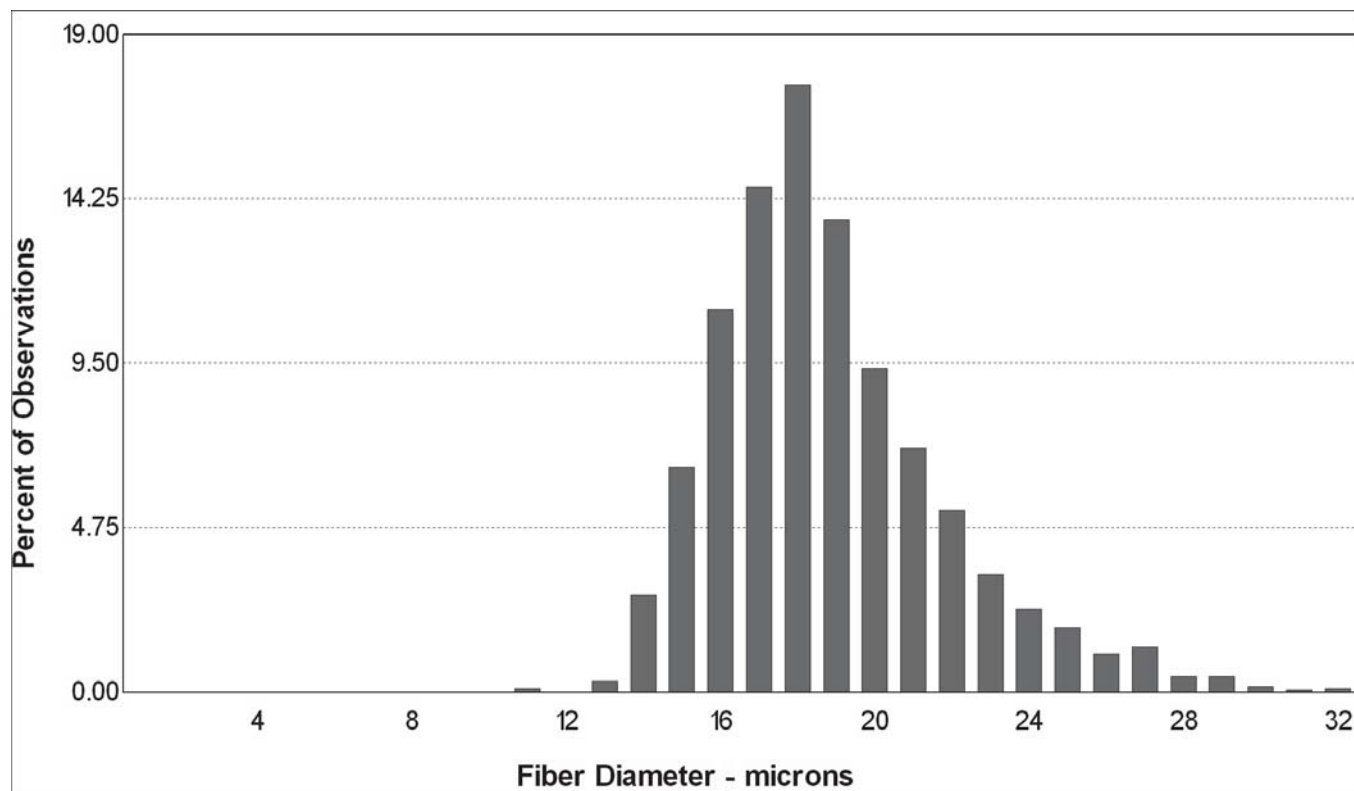
**Mean Fiber Diameter:** 18.9 microns  
**Standard Deviation:** 3.4 microns  
**Coefficient of Variation:** 17.8 %  
**Fibers Greater Than 30 microns:** 0.7 %

This Test Performed According to I.W.T.O Method 12
