## Sirolan Laserscan Micron Test Report

Raynay Alpaca Farm/Candy McMahan  
1897 Ashland Road  
Ruffin NC 27326 USA

Test No: 974025

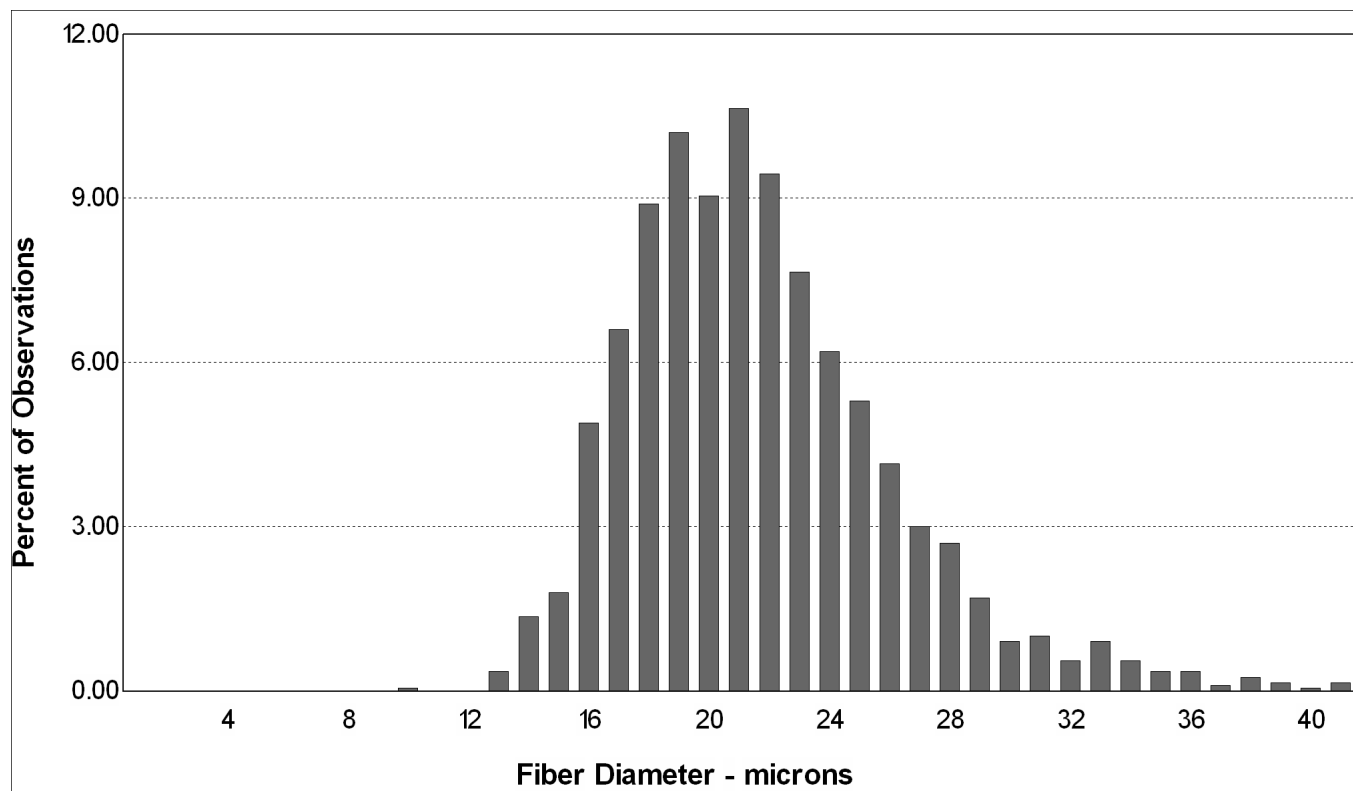
**Mean Fiber Diameter:** 21.9 microns  
**Standard Deviation:** 5.0 microns  
**Coefficient of Variation:** 22.8 %  
**Fibers Greater Than 30 microns:** 5.1 %

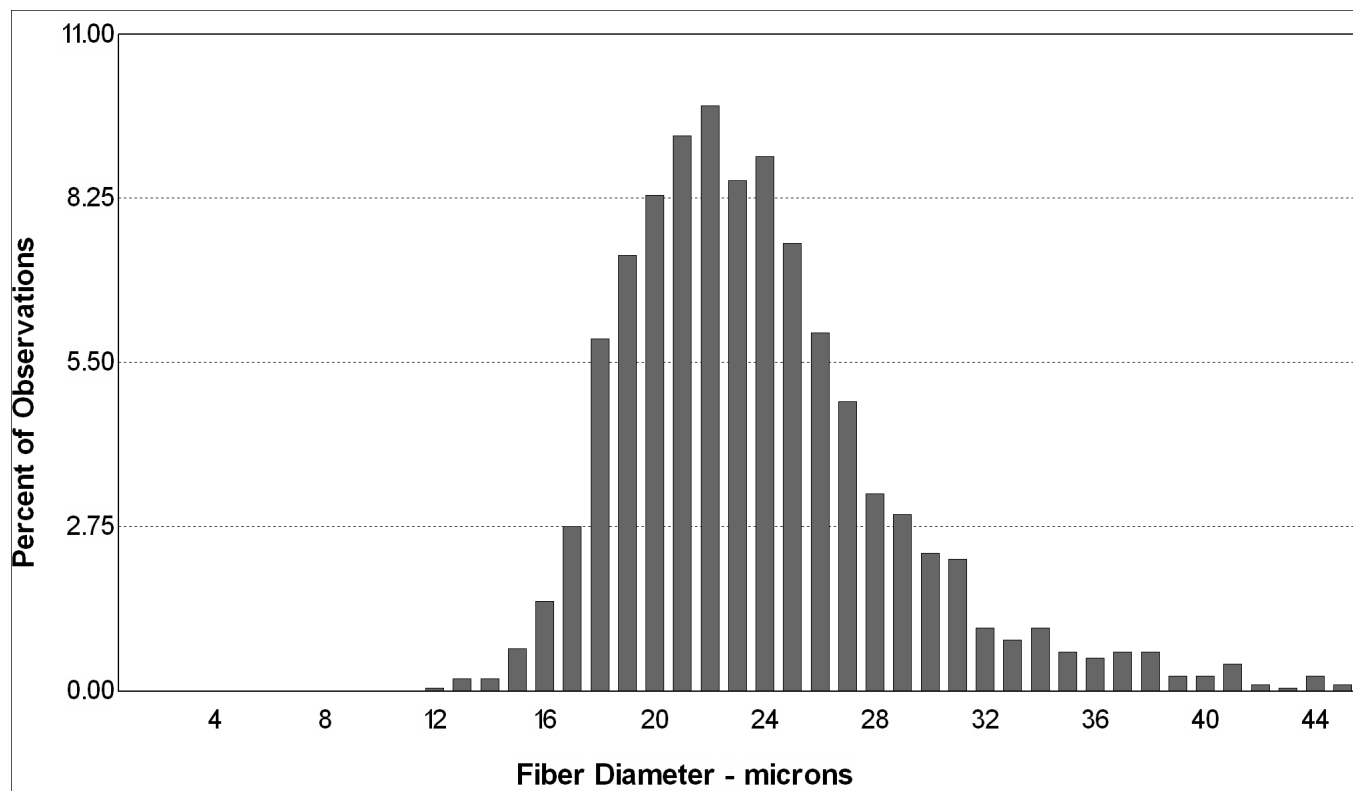
**Mean Fiber Diameter:** 23.8 microns  
**Standard Deviation:** 5.3 microns  
**Coefficient of Variation:** 22.3 %  
**Fibers Greater Than 30 microns:** 9.6 %

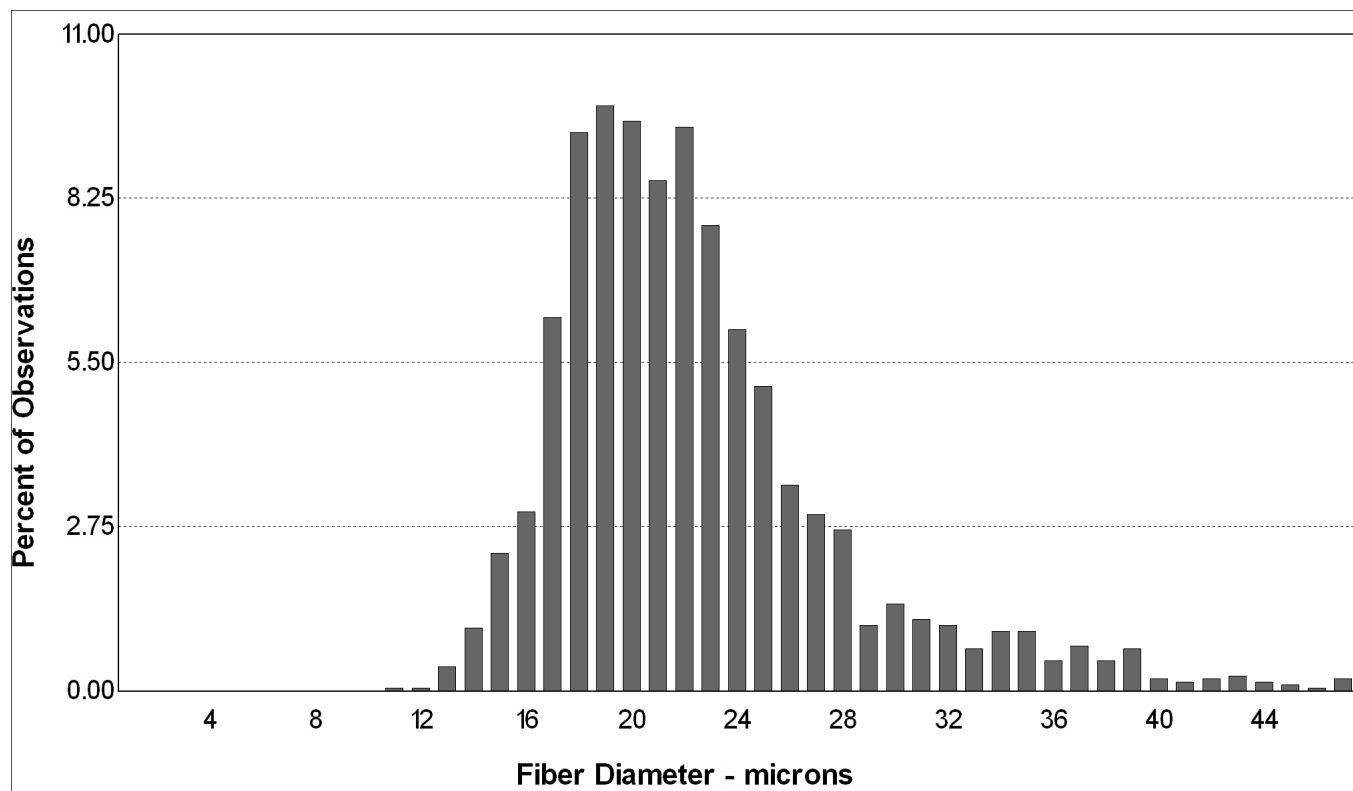
**Mean Fiber Diameter:** 22.7 microns  
**Standard Deviation:** 6.2 microns  
**Coefficient of Variation:** 27.1 %  
**Fibers Greater Than 30 microns:** 9.6 %

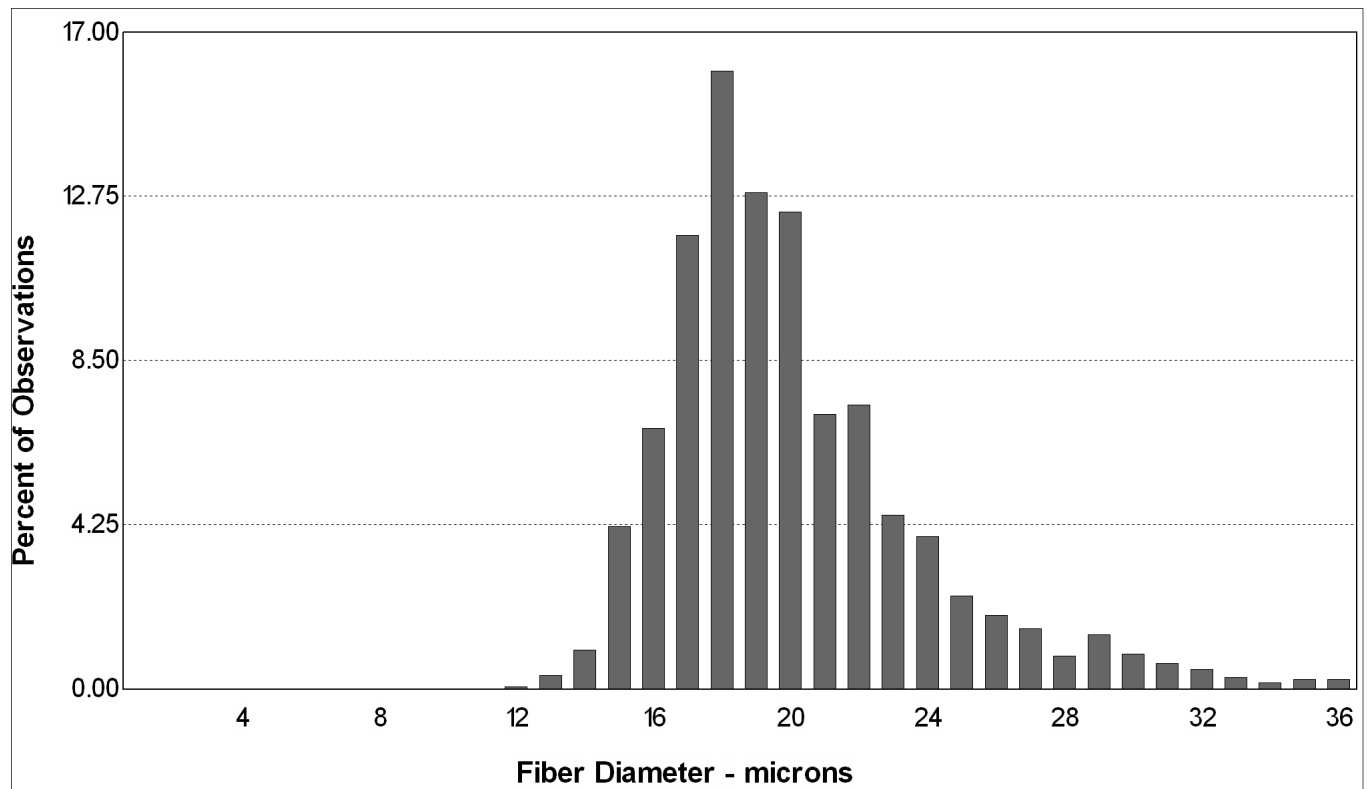
**Mean Fiber Diameter:** 20.2 microns  
**Standard Deviation:** 4.1 microns  
**Coefficient of Variation:** 20.2 %  
**Fibers Greater Than 30 microns:** 2.8 %

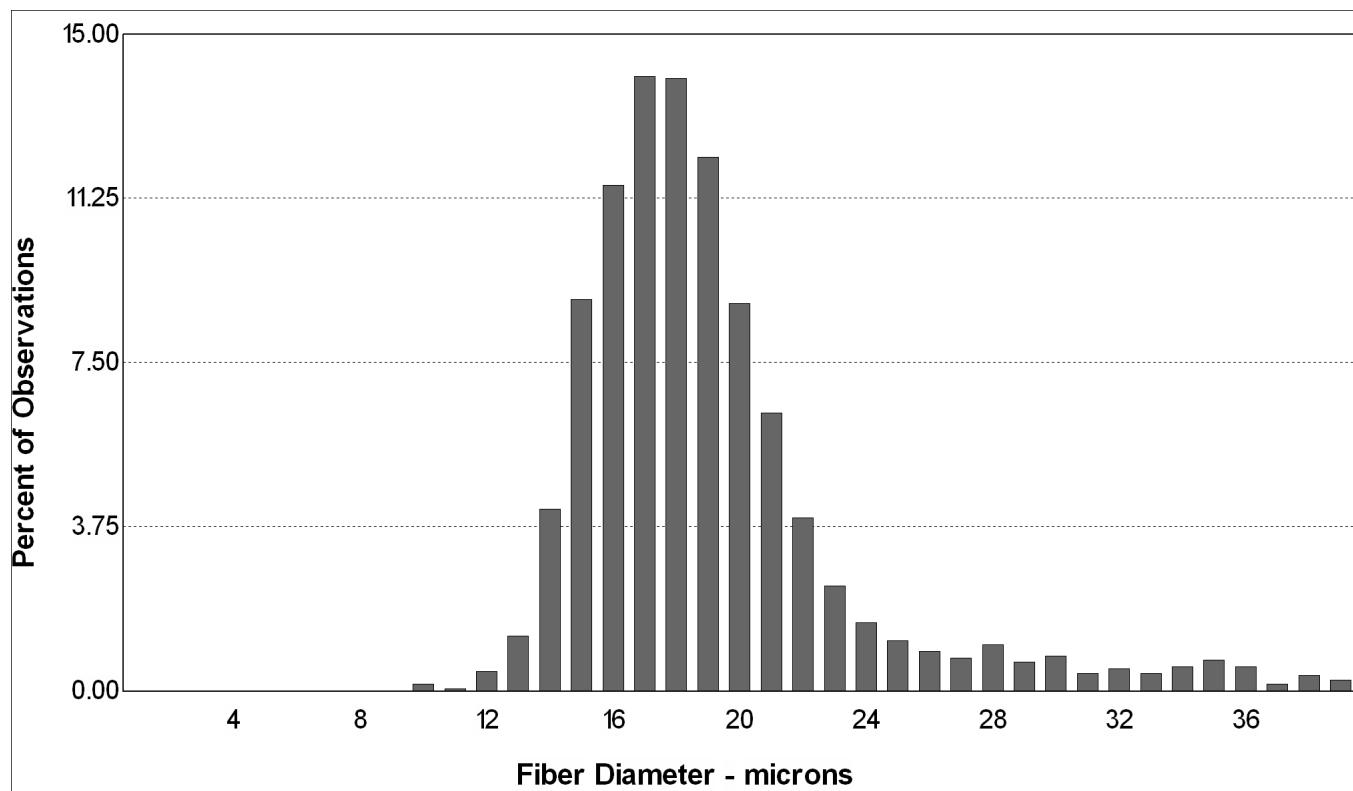
**Mean Fiber Diameter:** 19.3 microns  
**Standard Deviation:** 5.0 microns  
**Coefficient of Variation:** 26.0 %  
**Fibers Greater Than 30 microns:** 4.8 %

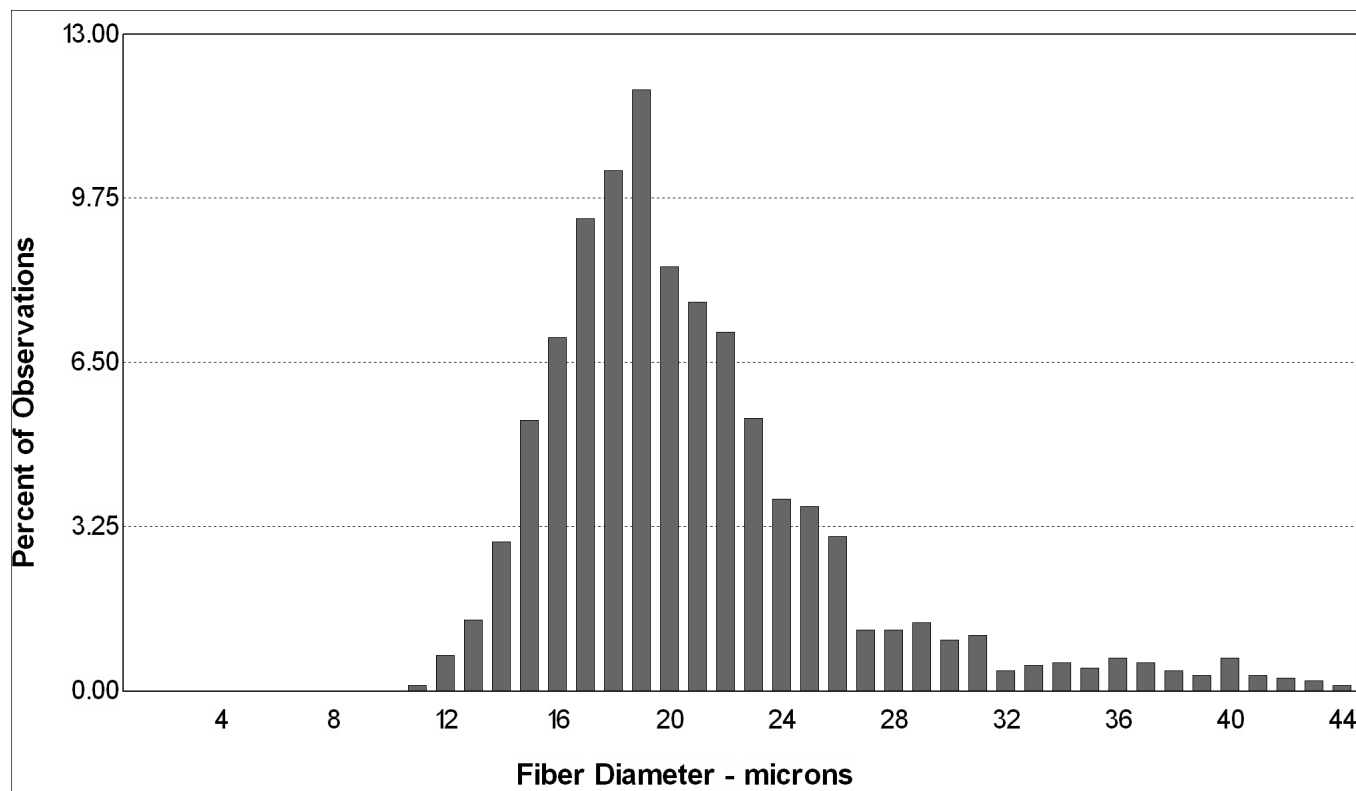
**Mean Fiber Diameter:** 21.0 microns  
**Standard Deviation:** 5.9 microns  
**Coefficient of Variation:** 28.1 %  
**Fibers Greater Than 30 microns:** 7.1 %

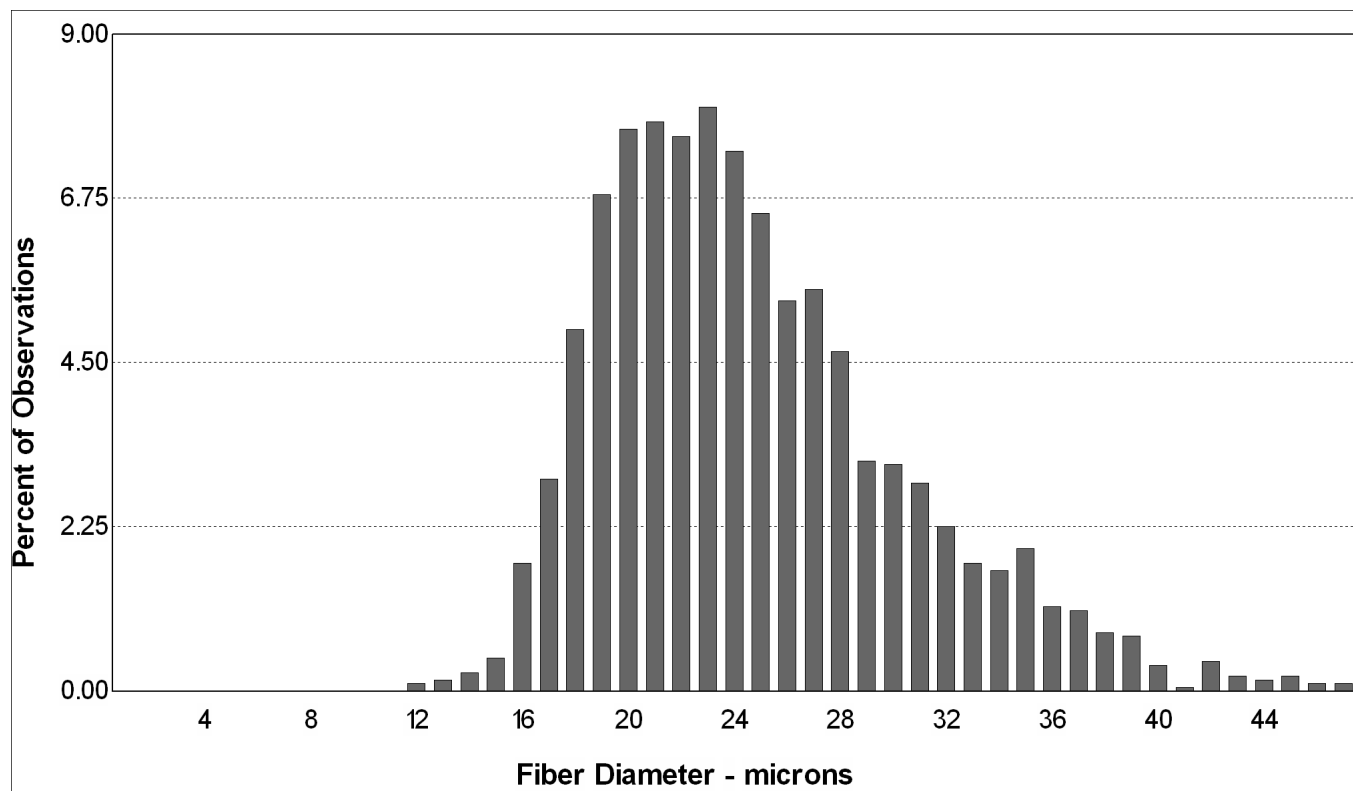
**Mean Fiber Diameter:** 24.7 microns  
**Standard Deviation:** 5.7 microns  
**Coefficient of Variation:** 23.2 %  
**Fibers Greater Than 30 microns:** 15.9 %

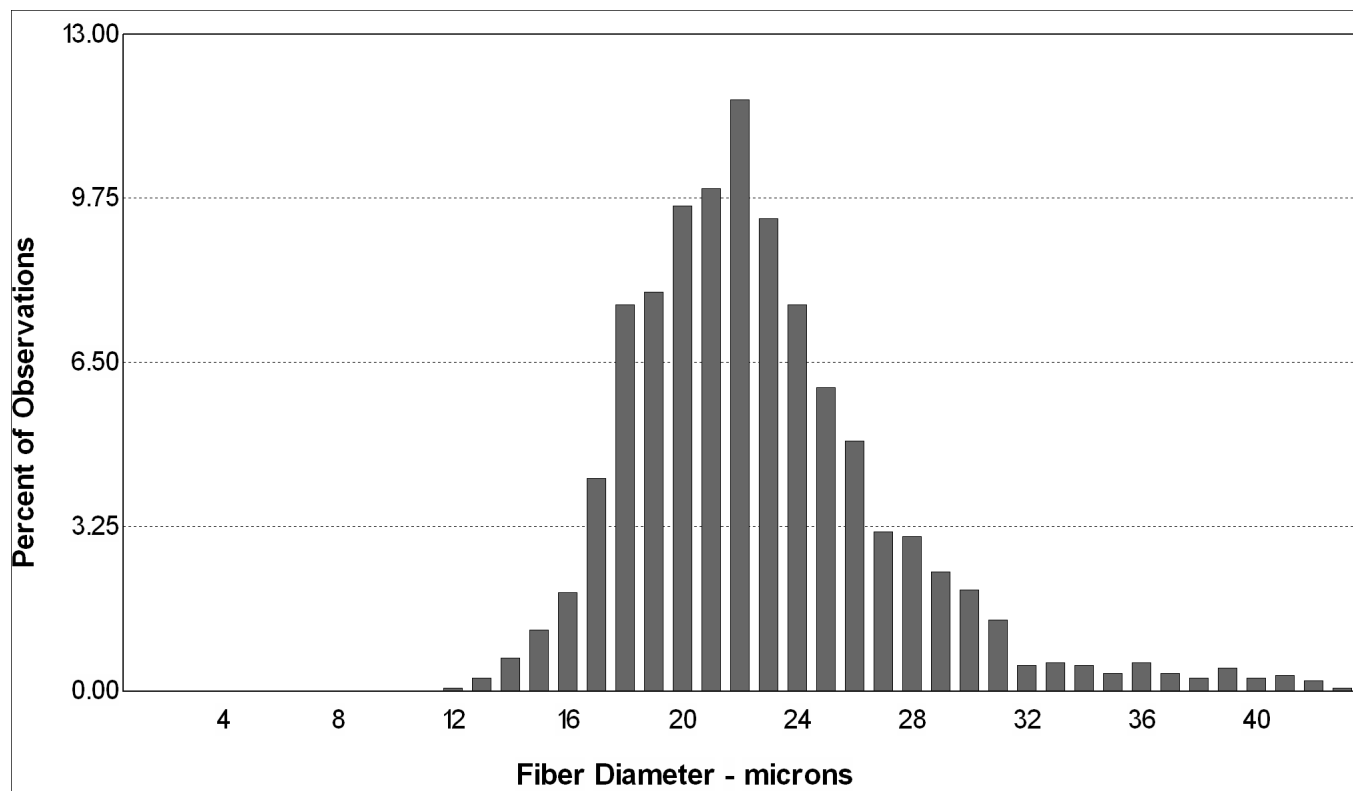
**Mean Fiber Diameter:** 22.9 microns  
**Standard Deviation:** 5.1 microns  
**Coefficient of Variation:** 22.3 %  
**Fibers Greater Than 30 microns:** 6.4 %

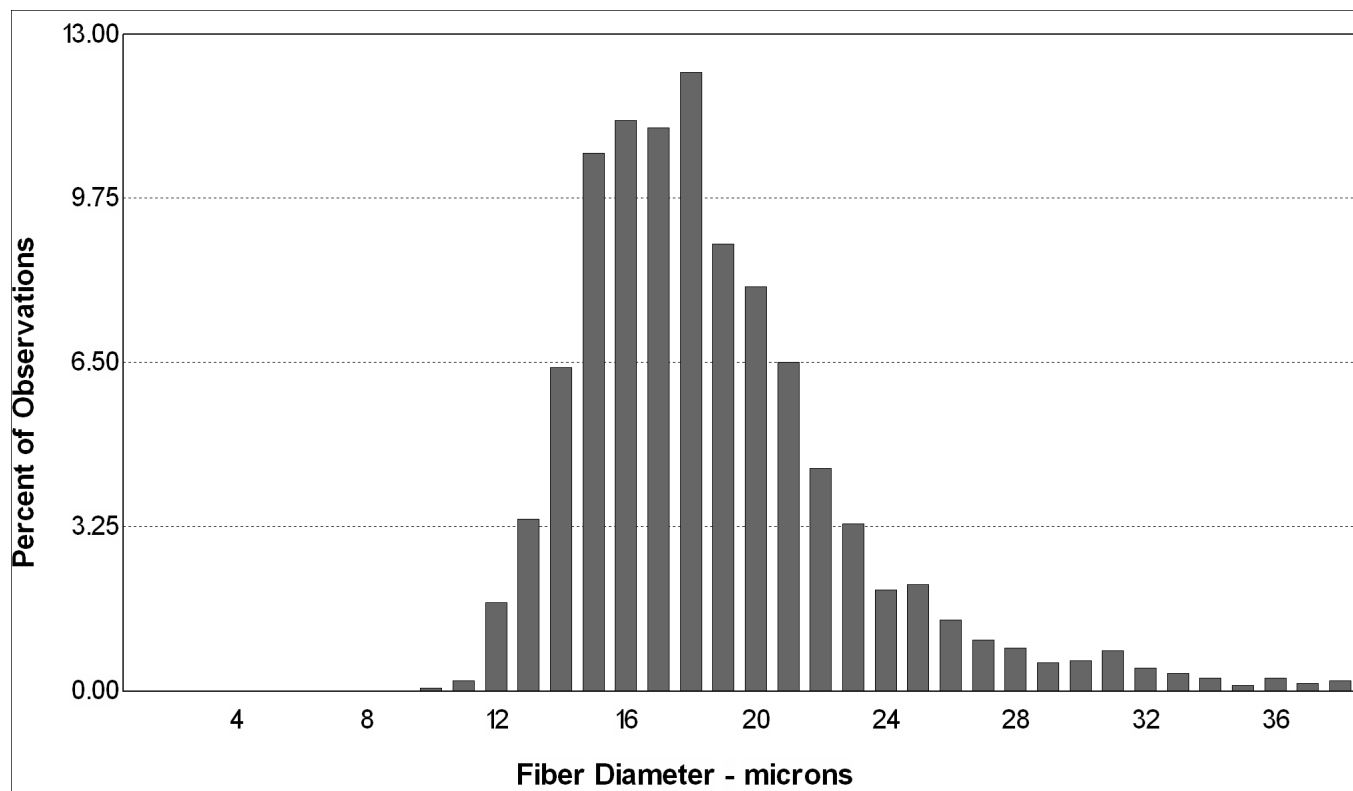
**Mean Fiber Diameter:** 18.9 microns  
**Standard Deviation:** 4.8 microns  
**Coefficient of Variation:** 25.6 %  
**Fibers Greater Than 30 microns:** 3.3 %

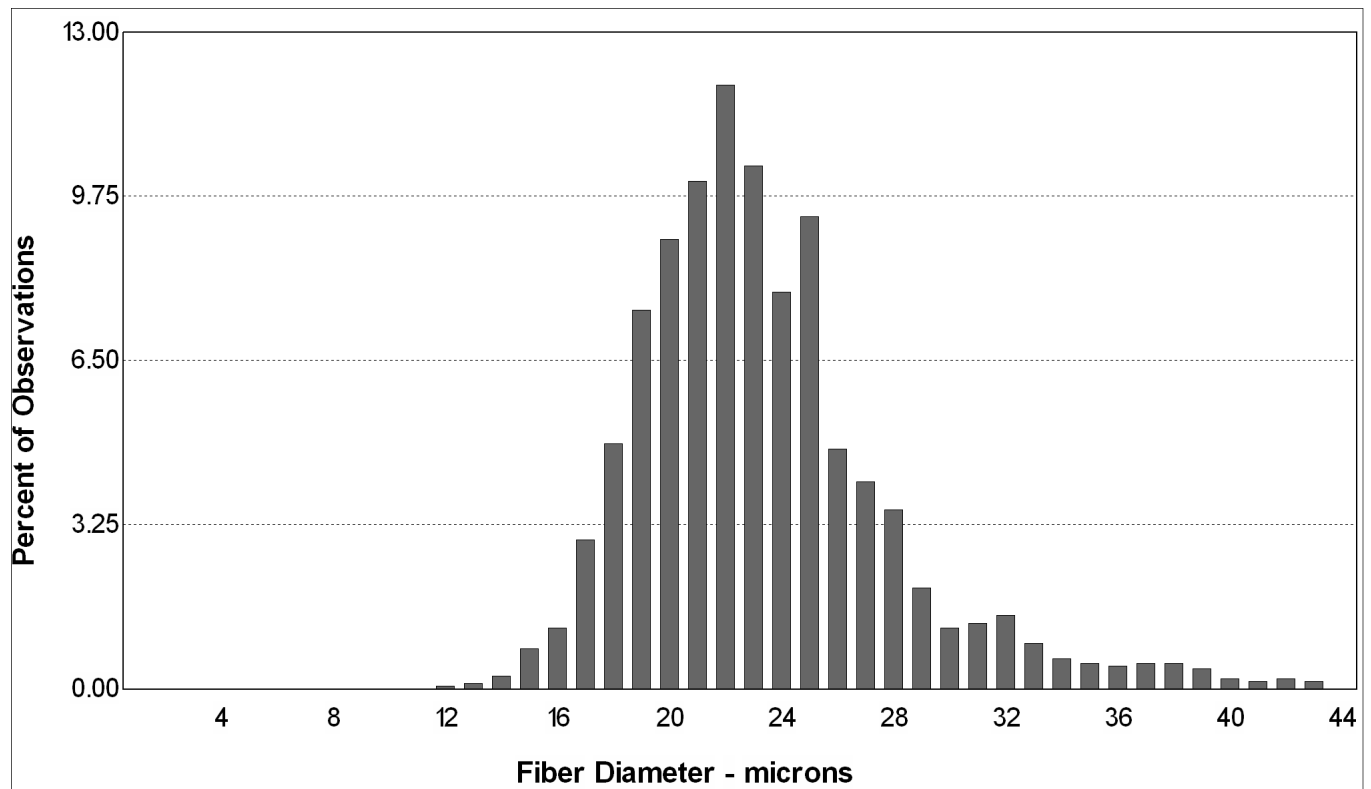
**Mean Fiber Diameter:** 23.6 microns  
**Standard Deviation:** 5.2 microns  
**Coefficient of Variation:** 22.1 %  
**Fibers Greater Than 30 microns:** 8.3 %

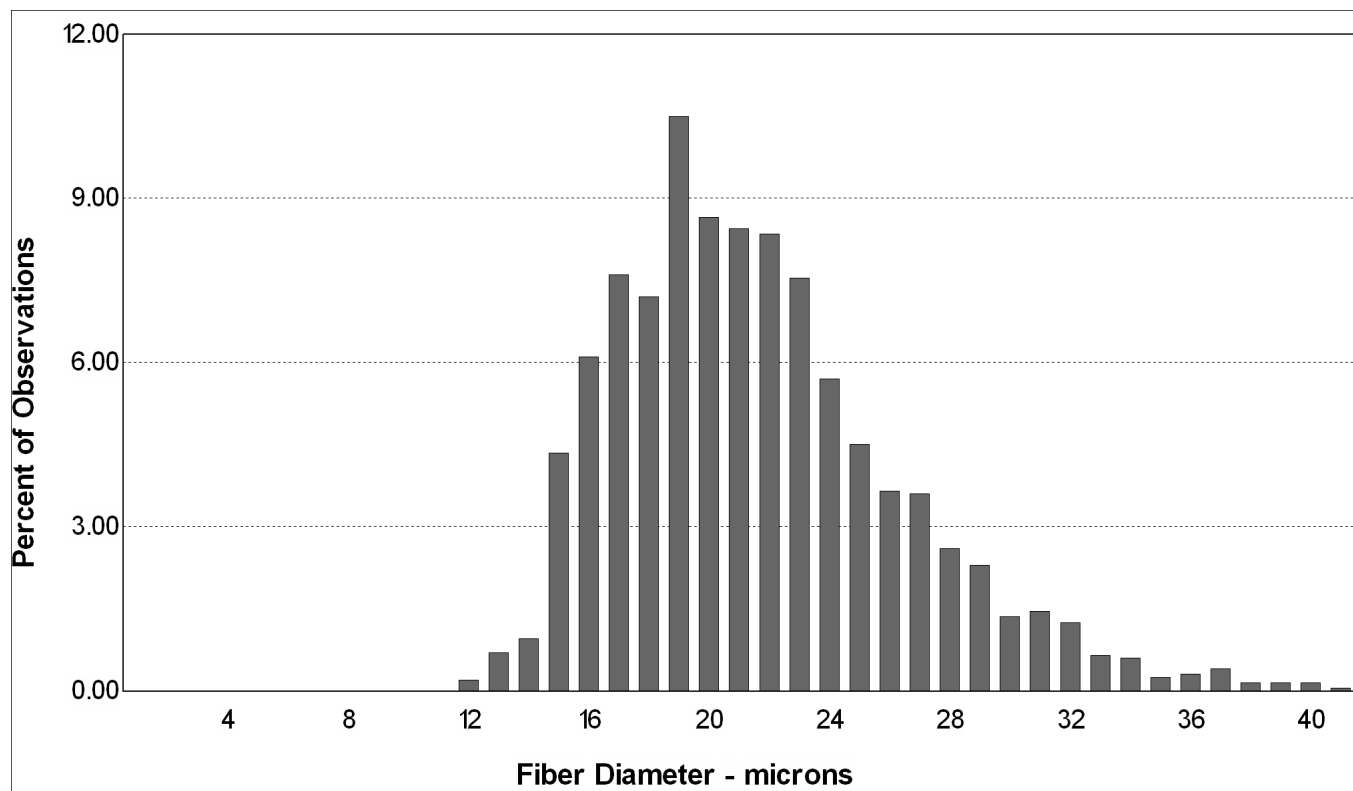
**Mean Fiber Diameter:** 21.7 microns  
**Standard Deviation:** 4.9 microns  
**Coefficient of Variation:** 22.7 %  
**Fibers Greater Than 30 microns:** 5.7 %
