## Sirolan Laserscan Micron Test Report

**Test No:** 906279

**Animal Name:** Diamonte of PVA  
**Breed:** Alpaca(Suri)  
**Sex:** Male  
**Color:** True Black

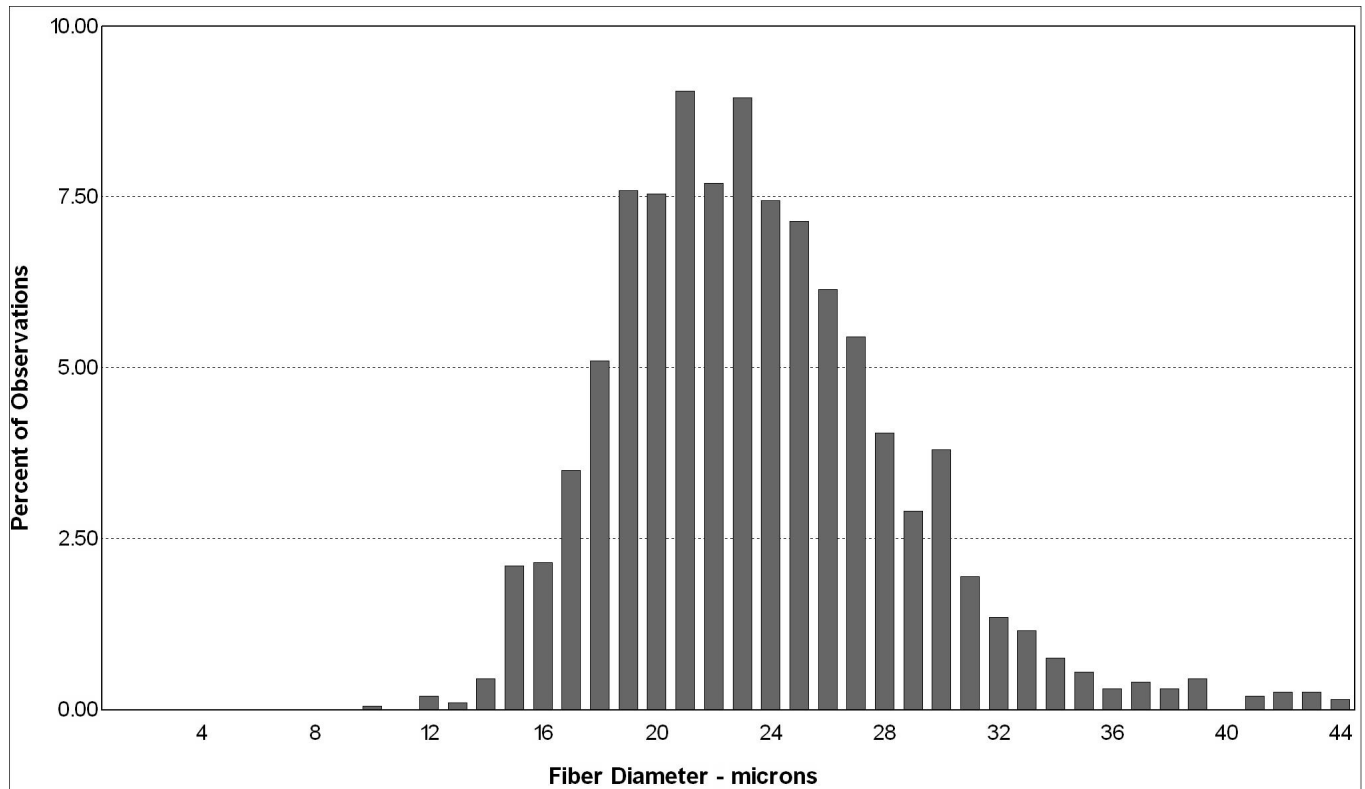
**Mean Fiber Diameter:** 23.7 microns  
**Standard Deviation:** 5.3 microns  
**Coefficient of Variation:** 22.4 %  
**Fibers Greater Than 30 microns:** 8.6 %
