**Sirolan Laserscan
Micron Test Report**

Kendall Creek Farms/Chris & Lori Works
41 Looker Mountain Trail
Bradford PA 16701 USA

Test No: 488308

Animal Name: KCF Peruvian Shelby
Breed: Alpaca(Huacaya)
Sex: Male
Color: WH

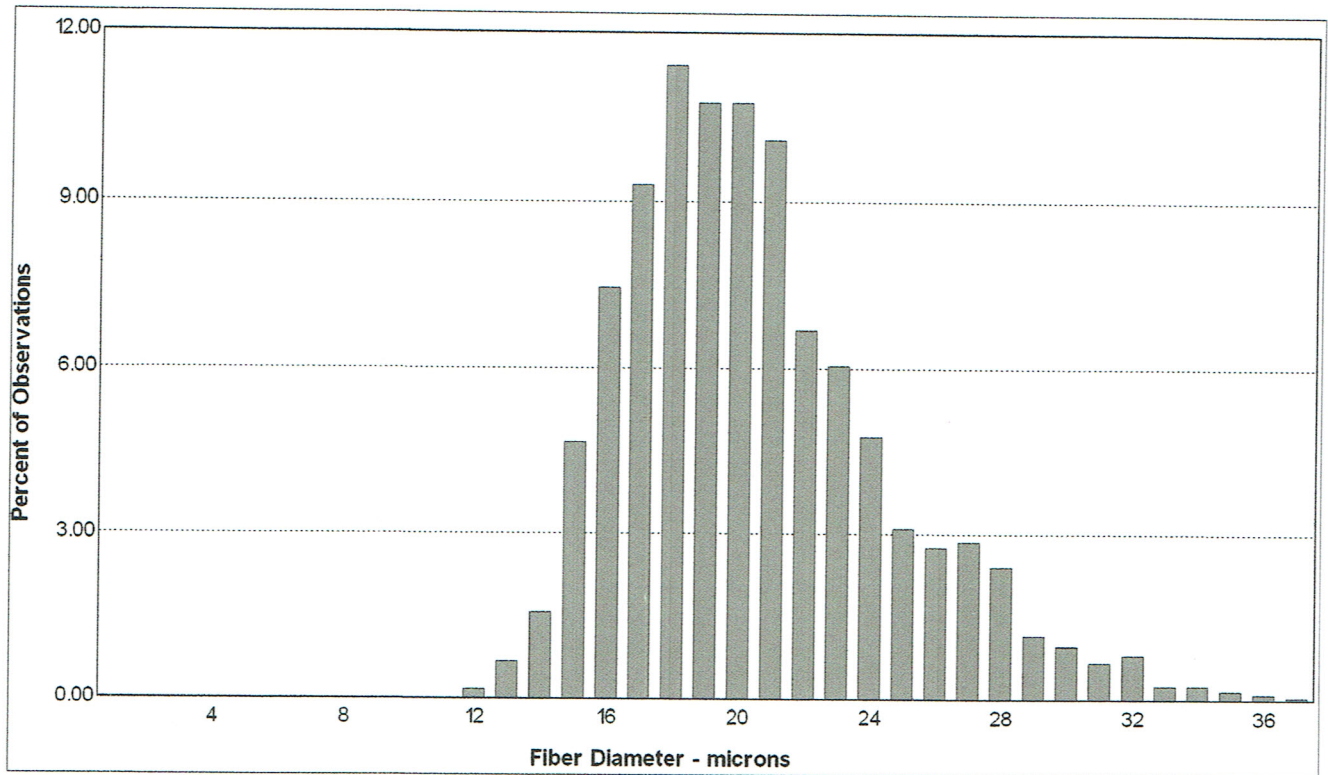
Mean Fiber Diameter: 20.6 microns
Standard Deviation: 4.2 microns
Coefficient of Variation: 20.6 %
Fibers Greater Than 30 microns: 2.6 %

This Test Performed According to I.W.T.O Method 12
