## Sirolan Laserscan Micron Test Report

**Test No:** 987585

### Animal and Sample Description

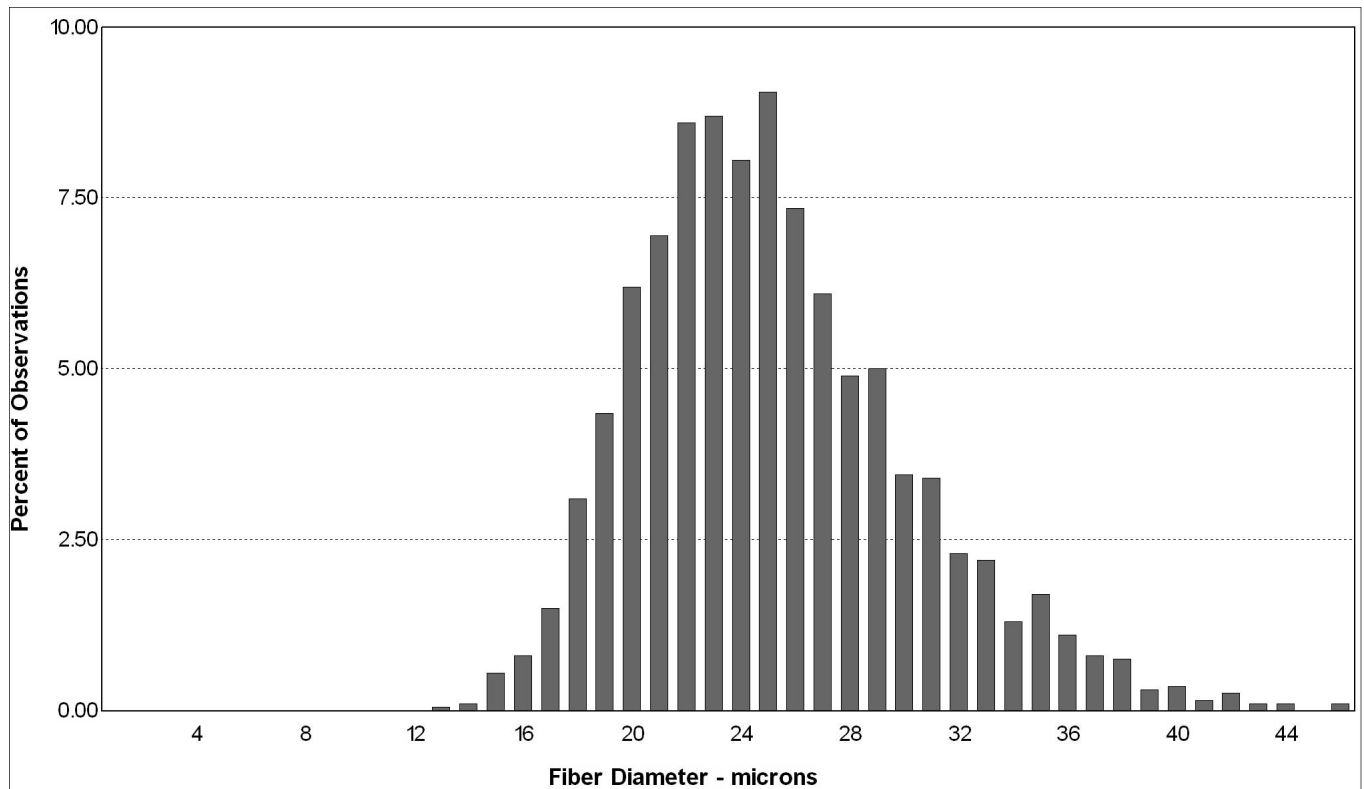
**Mean Fiber Diameter:** 25.3 microns  
**Standard Deviation:** 5.3 microns  
**Coefficient of Variation:** 20.8 %  
**Fibers Greater Than 30 microns:** 15.2 %
